To: Erin Janicki[erin_janicki@nps.gov]
Cc: Dana Backer[dbacker@blm.gov]
From: Betenson, Matthew
Sent: 2017-11-06T17:14:43-05:00
Importance: Normal
Subject: HITR Road 2
Received: 2017-11-06T17:15:20-05:00
[Special Recreation Management Areas Board.pdf](#)
[Schedule and EA and Comment Process Board.pdf](#)
[Road Design Rendering Board.pdf](#)
[Project Corridor Board.pdf](#)
[Management Zones Board.pdf](#)
[Maintenance Board.pdf](#)
[Environmental Resources Board.pdf](#)
[Background Board.pdf](#)

Department of Interior
Grand Staircase-Escalante
National Monument

For over twenty years, Hole-in-the-Rock Road (HITRR) has been maintained by continuously using heavy equipment to flatten washboarding, construct wing ditches, repair muddy areas, and utilize spot gravelling. The result is a deteriorated road condition which continues to widen and entrench, causing increased erosion on and around the road. This creates impassable muddy areas.

This project is to restore and repair the HITRR as a natural surface road that will improve driving safety and visitor experience, provide for better drainage, require less maintenance, and protect resources along the road.

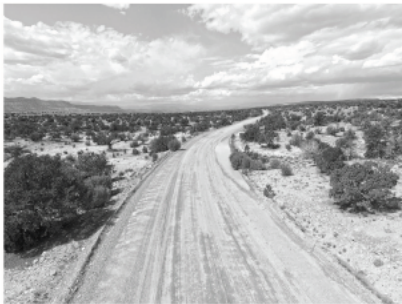
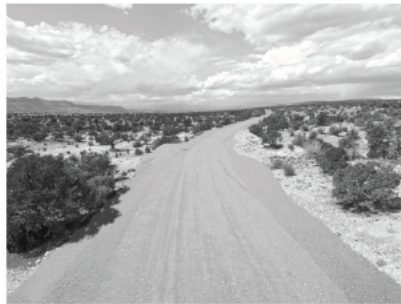
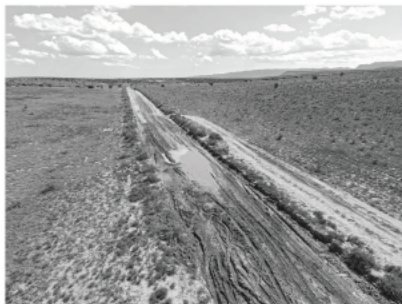
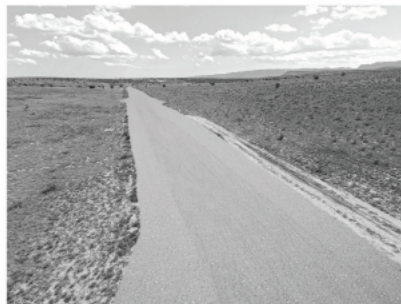
CONCEPTUAL RENDERING OF REPAIRS

BEFORE

AFTER

- In locations where the road is deeply entrenched, adjacent slopes may need to be contoured and revegetated.
- Over time, vegetation will naturally move into the disturbed areas along the road.

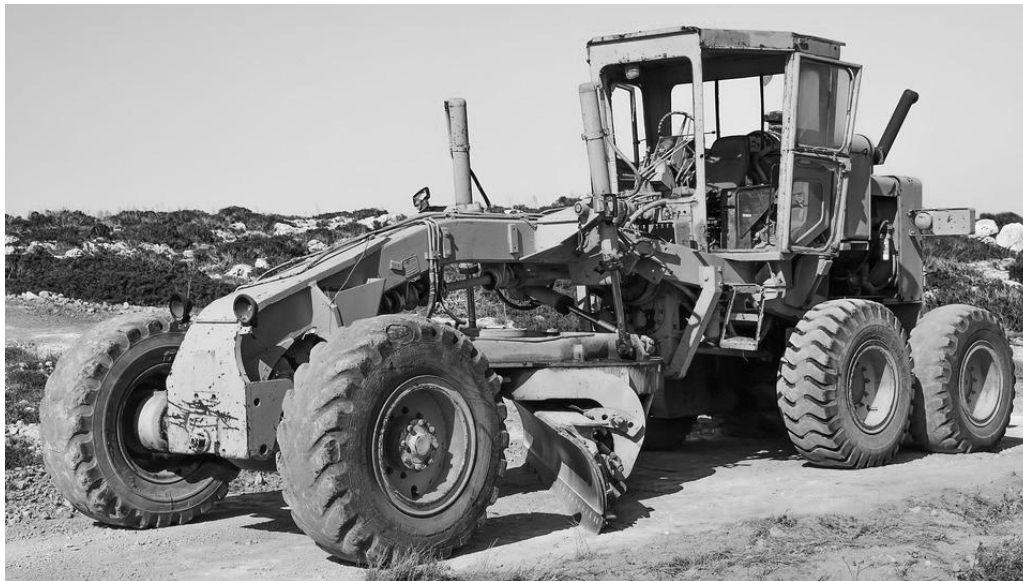
Maintenance on the Road

The proposed project would repair the natural surface road, with gravel placed in problem areas. This grading and drainage project would result in a crown and ditch road bed that will help the road shed water and return it to a consistent width.

- Hole-in-the-Rock Road is currently graded approximately 20 times each summer, creating additional costs to Garfield County. Regular grading also causes degradation of the road base due to constant manipulation, which creates hazardous driving conditions for visitors.
- Heavy equipment will only be staged in previously disturbed areas.
